**Flood Control Project Maintenance
Levee Inspections**

Fall 2013 Levee Maintenance Deficiency Summary Report

Reclamation District No. 0563 Tyler Island

Waterway			Bank	Unit Miles
Unit No. 01 Georgiana Slough (Tyler Island)			Left	12.38
	Spring (March - May)	Summer (June - August)	(September - November) Fall	Winter (December - February)
Unit Maintenance Rating (Fall Only)			U	
Date of Inspection	04/24/2013 - 04/24/2013		10/15/2013 - 10/16/2013	
DWR Inspector	Richard Willoughby		Richard Willoughby	
Accompanied By	Steve Mello RD 563		Steve Mello RD 563

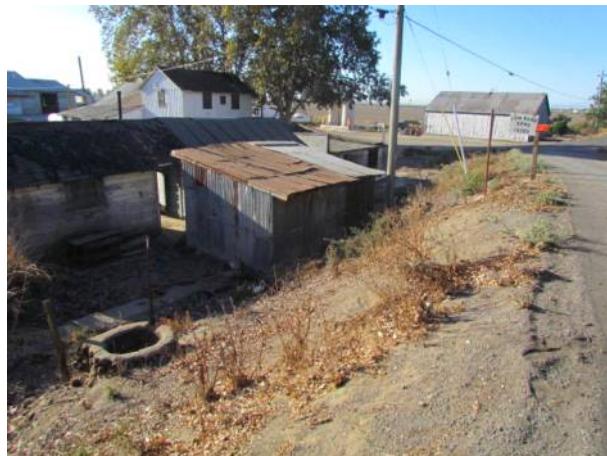
Levee Mile Report Line	8
Start Levee Mile	0.17
End Levee Mile	0.17
Location	Land Side
Category	Earthen Levee
Item	Encroachments
Looking southeast at storage shed at landward toe.	
richard_f_20131021_094.JPG

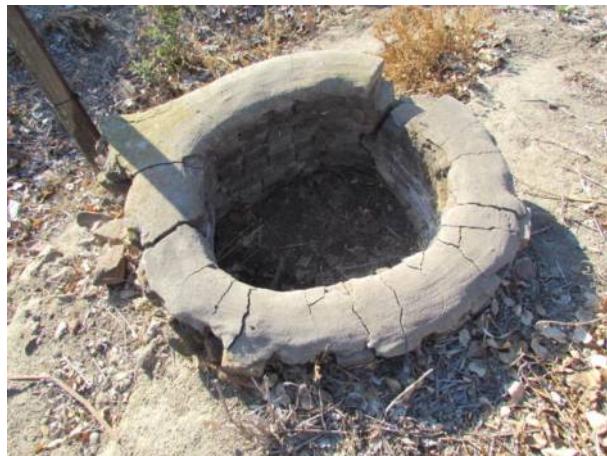
Levee Mile Report Line	8
Start Levee Mile	0.17
End Levee Mile	0.17
Location	Land Side
Category	Earthen Levee
Item	Encroachments
Looking southeast at fire pit on landward slope.	
richard_f_20131021_095.JPG

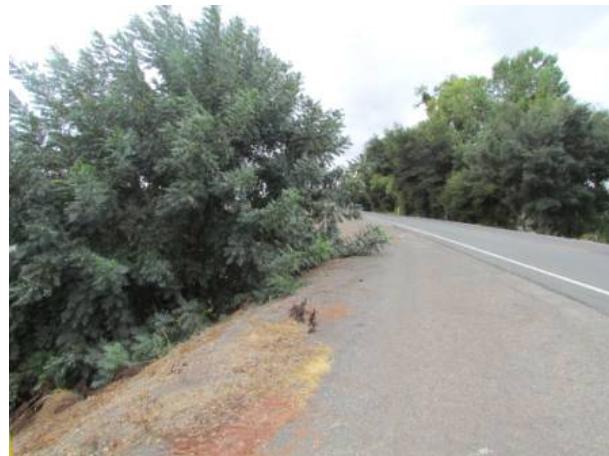
Levee Mile Report Line	11
Start Levee Mile	0.21
End Levee Mile	0.21
Location	Land Side
Category	Earthen Levee
Item	Trim / Thin Trees
Looking southwest at overgrown trees on landside slope.	
richard_f_20130930_603.jpg

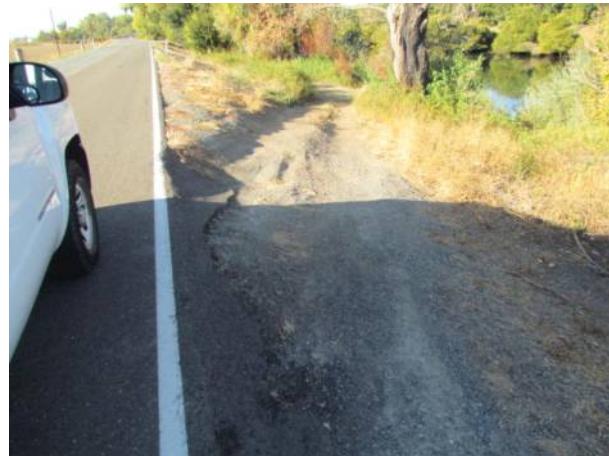
Levee Mile Report Line	12
Start Levee Mile	0.41
End Levee Mile	0.41
Location	Water Side
Category	Earthen Levee
Item	Slope Stability
Looking southwest at slope damage caused by vehicle traffic.	
richard_f_20131021_096.JPG

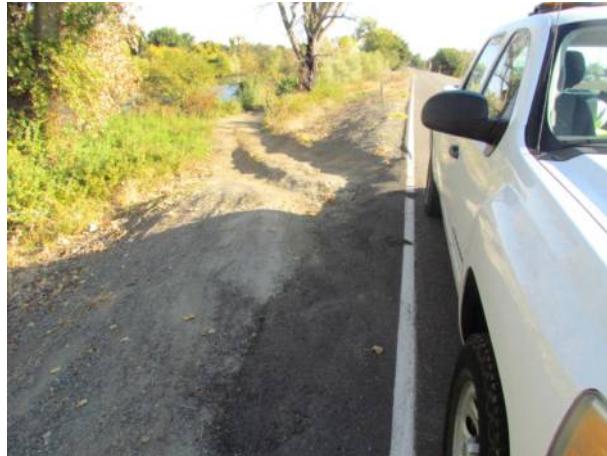
Levee Mile Report Line	13
Start Levee Mile	0.45
End Levee Mile	0.45
Location	Water Side
Category	Earthen Levee
Item	Slope Stability
Looking northwest at slope damage caused by vehicle traffic.	
richard_f_20131021_097.JPG

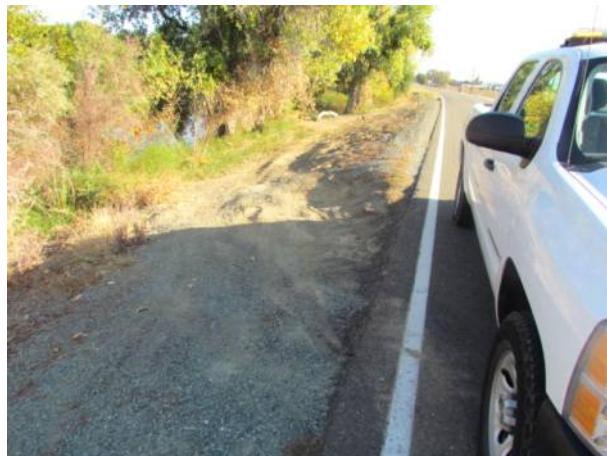
Levee Mile Report Line	14
Start Levee Mile	0.59
End Levee Mile	0.59
Location	Water Side
Category	Earthen Levee
Item	Slope Stability
Looking northwest at slope damage caused by vehicle traffic.	
richard_f_20131021_098.JPG

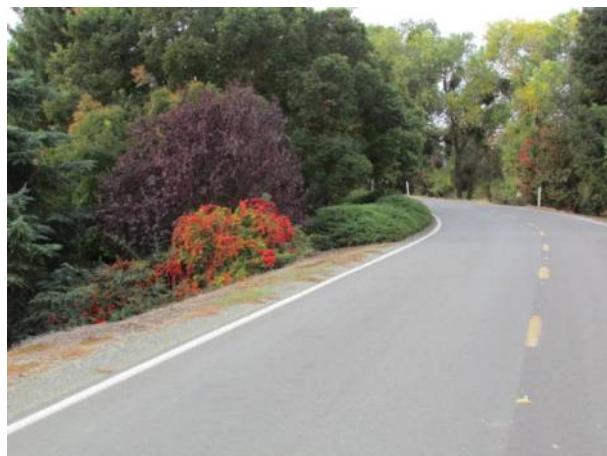
Levee Mile Report Line	15
Start Levee Mile	0.68
End Levee Mile	0.71
Location	Land Side
Category	Earthen Levee
Item	Vegetation
Looking southeast at dense landscaping on landside slope.	
richard_f_20130930_659.JPG

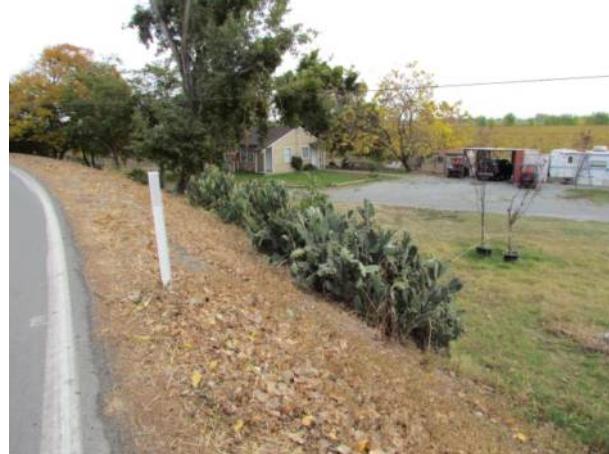
Levee Mile Report Line	18
Start Levee Mile	0.86
End Levee Mile	0.86
Location	Land Side
Category	Earthen Levee
Item	Vegetation
Looking northwest at cactus along landside toe.	
richard_f_20130930_689.JPG

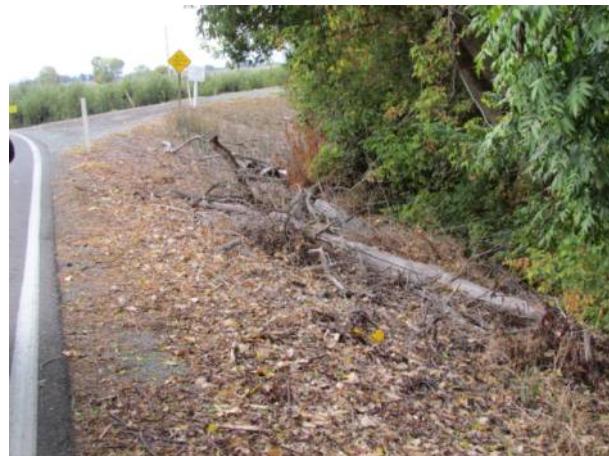
Levee Mile Report Line	19
Start Levee Mile	0.86
End Levee Mile	0.86
Location	Water Side
Category	Earthen Levee
Item	Encroachments
Looking southwest at tree limbs on waterside slope.	
richard_f_20130930_595.JPG

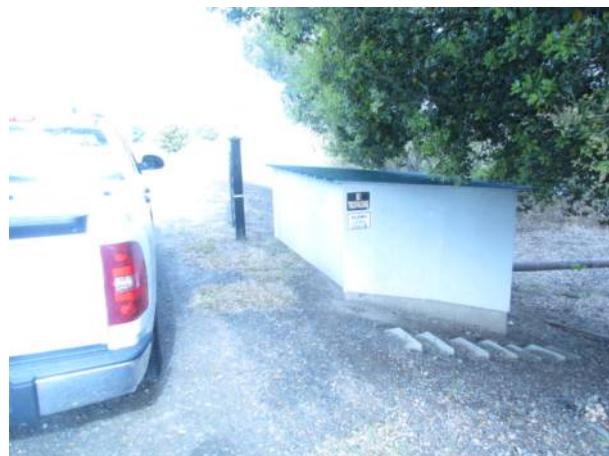
Levee Mile Report Line	20
Start Levee Mile	0.95
End Levee Mile	0.95
Location	Crown
Category	Earthen Levee
Item	Encroachments
Looking south at pump shed on waterside slope and gate across levee crown.	
richard_f_20130930_599.jpg

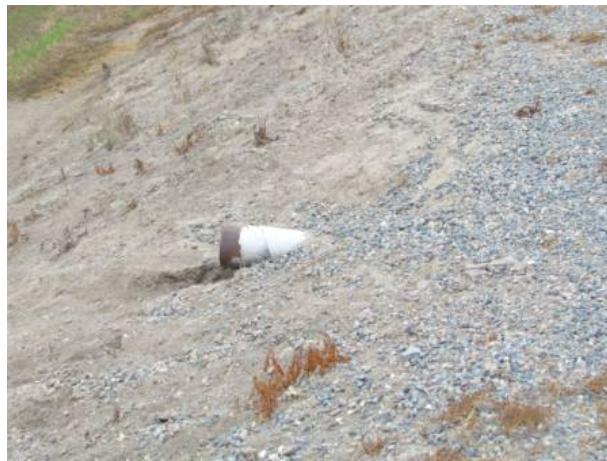
Levee Mile Report Line	21
Start Levee Mile	0.98
End Levee Mile	0.98
Location	Crown
Category	Earthen Levee
Item	Encroachments
Looking southwest at abandoned pipe on landside slope.	
richard_f_20130930_731.jpg

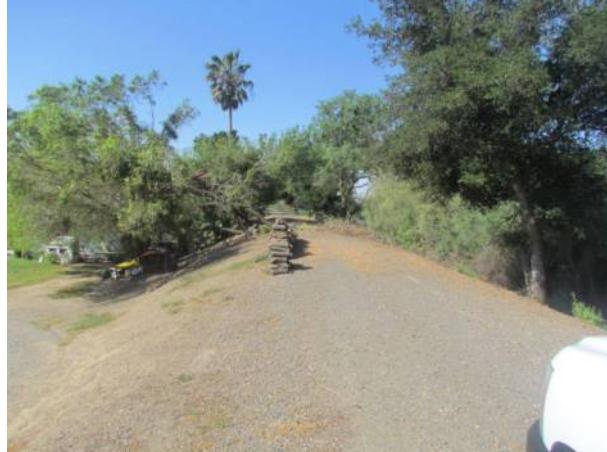
Levee Mile Report Line	26
Start Levee Mile	1.23
End Levee Mile	1.25
Location	Land Side
Category	Earthen Levee
Item	Encroachments
Looking south at firewood piled on landward and waterward shoulder.	
richard_f_20130930_692.JPG

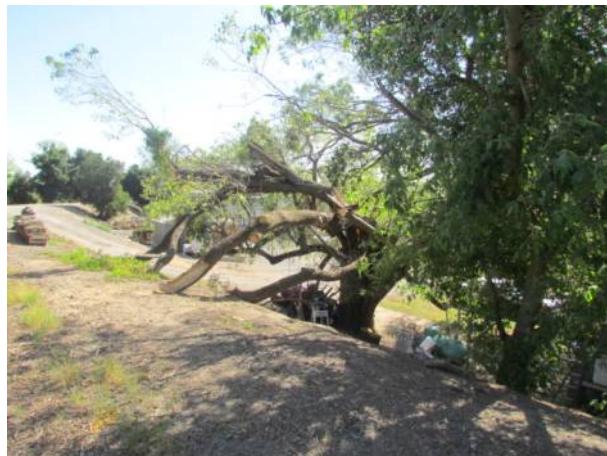
Levee Mile Report Line	28
Start Levee Mile	1.25
End Levee Mile	1.25
Location	Land Side
Category	Earthen Levee
Item	Encroachments
Looking northeast at broken tree branch on landward slope.	
richard_f_20130930_729.JPG

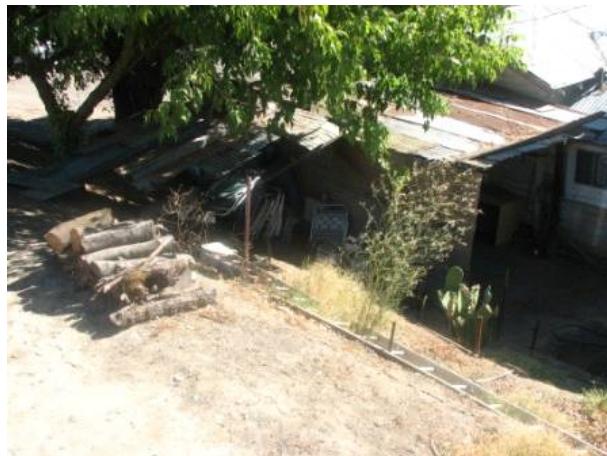
Levee Mile Report Line	29
Start Levee Mile	1.25
End Levee Mile	1.25
Location	Land Side
Category	Earthen Levee
Item	Encroachments
Looking at a shed at landside toe.	
richard_f_20130930_675.jpg

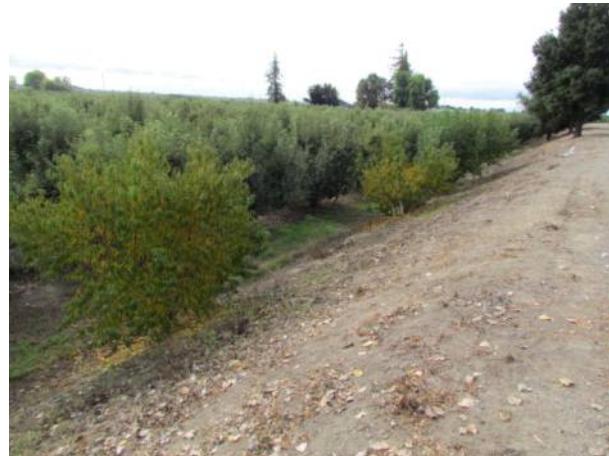
Levee Mile Report Line	30
Start Levee Mile	1.30
End Levee Mile	1.30
Location	Land Side
Category	Earthen Levee
Item	Trim / Thin Trees
Looking southeast at fruit trees on landside toe.	
richard_f_20130930_691.JPG

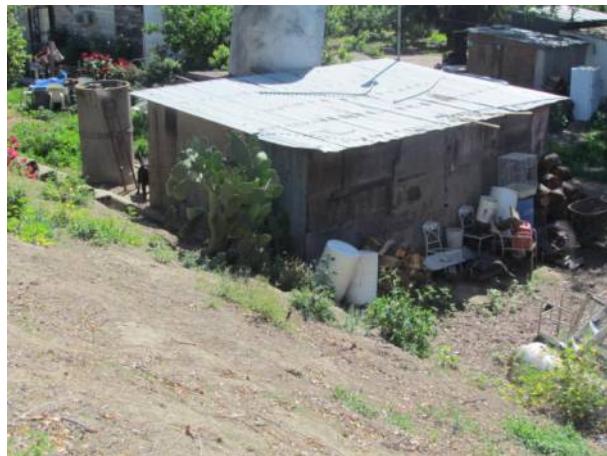
Levee Mile Report Line	35
Start Levee Mile	1.43
End Levee Mile	1.43
Location	Land Side
Category	Earthen Levee
Item	Encroachments
Looking northeast at a tool shed on the landward toe.	
richard_f_20130930_594.JPG

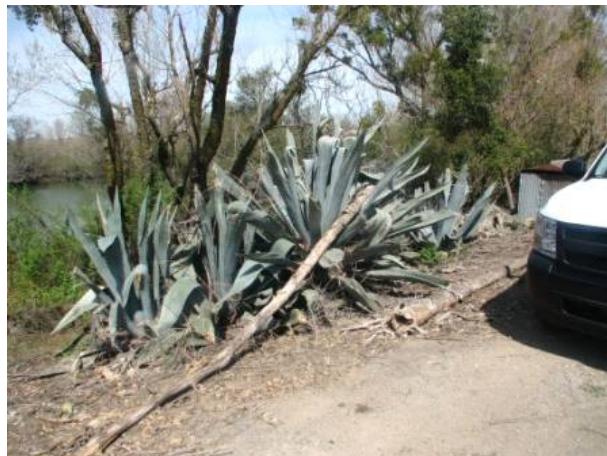
Levee Mile Report Line	36
Start Levee Mile	1.44
End Levee Mile	1.48
Location	Water Side
Category	Earthen Levee
Item	Vegetation
Century plant on waterward shoulder at LM 1.42	
richard_f_20130930_590.jpg

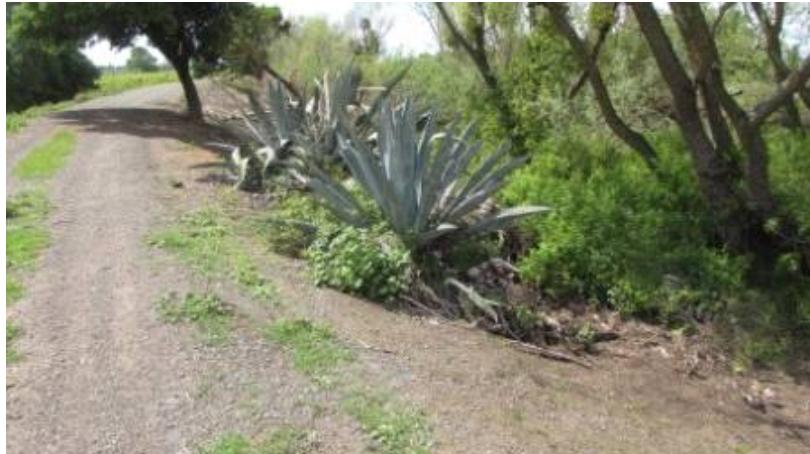
Updated view looking upstream at a century plant on waterside shoulder slope.

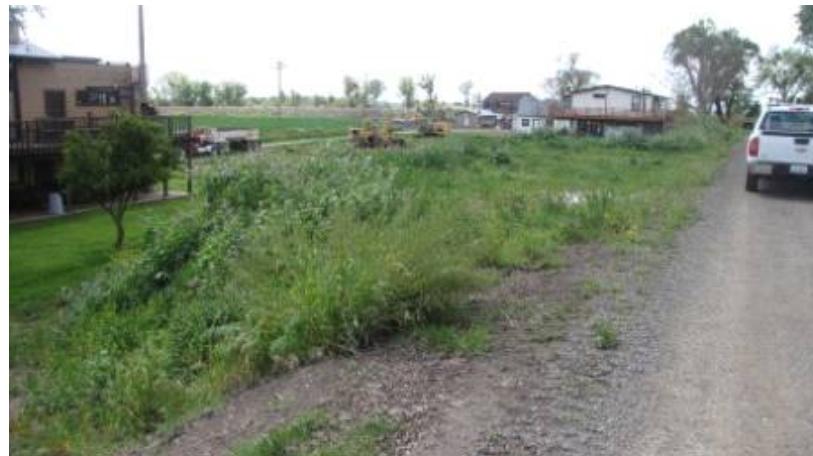
Levee Mile Report Line	41
Start Levee Mile	1.86
End Levee Mile	1.86
Location	Land Side
Category	Earthen Levee
Item	Encroachments
Looking southeast at earthen pad on landside shoulder covering retaining wall.	
richard_f_20130930_679.jpg

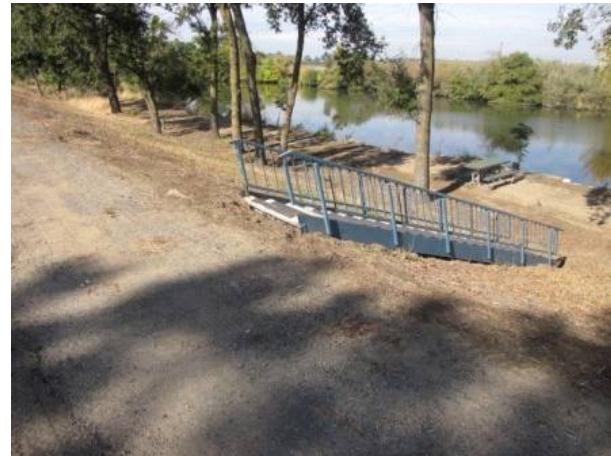
Levee Mile Report Line	41
Start Levee Mile	1.86
End Levee Mile	1.86
Location	Land Side
Category	Earthen Levee
Item	Encroachments
Looking west at metal stairs on waterside slope.	
richard_f_20130930_680.jpg

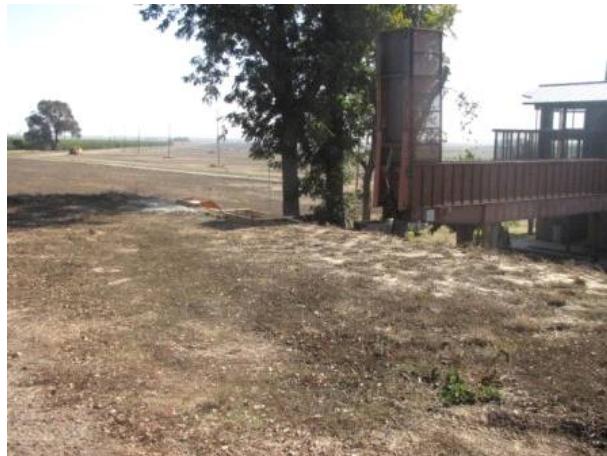
Levee Mile Report Line	41
Start Levee Mile	1.86
End Levee Mile	1.86
Location	Land Side
Category	Earthen Levee
Item	Encroachments
Looking northeast metal walkway on landside of levee.	
richard_f_20130930_681.jpg

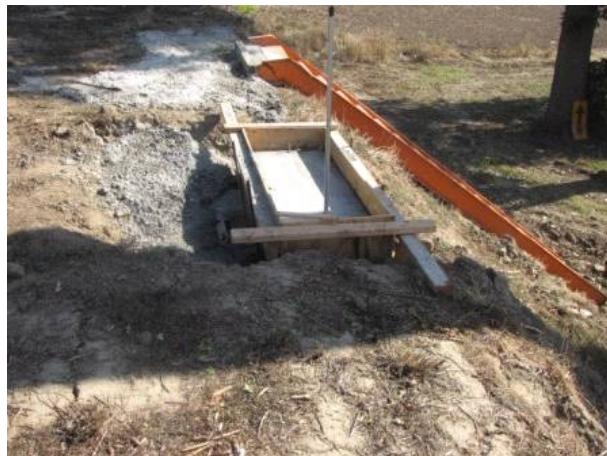
Levee Mile Report Line	41
Start Levee Mile	1.86
End Levee Mile	1.86
Location	Land Side
Category	Earthen Levee
Item	Encroachments
Looking north at deadman for metal walkway on earthen pad on landside shoulder.	
richard_f_20130930_682.jpg

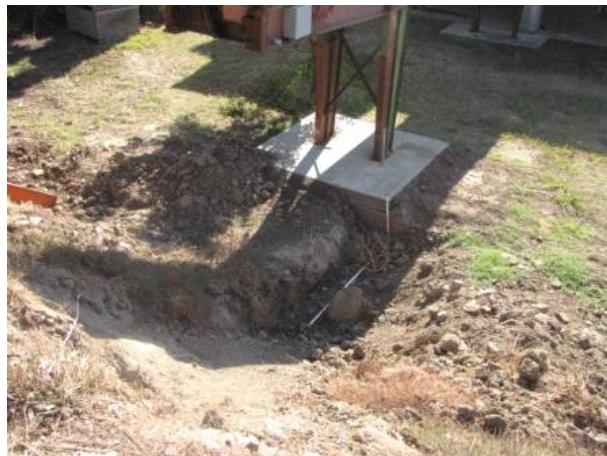
Levee Mile Report Line	41
Start Levee Mile	1.86
End Levee Mile	1.86
Location	Land Side
Category	Earthen Levee
Item	Encroachments
Looking east at electrical conduit in trench on landside toe and concrete pad for walkway.	
richard_f_20130930_683.jpg

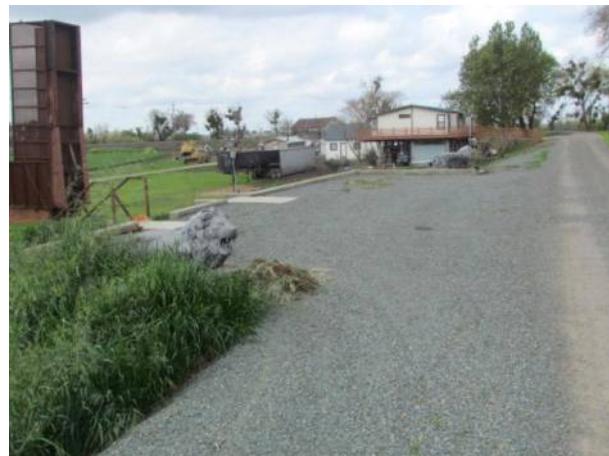
Levee Mile Report Line	41
Start Levee Mile	1.86
End Levee Mile	1.86
Location	Land Side
Category	Earthen Levee
Item	Encroachments
Looking south at retaining wall on landside shoulder. (Updated Spring 2012)	
richard_f_20130930_688.jpg

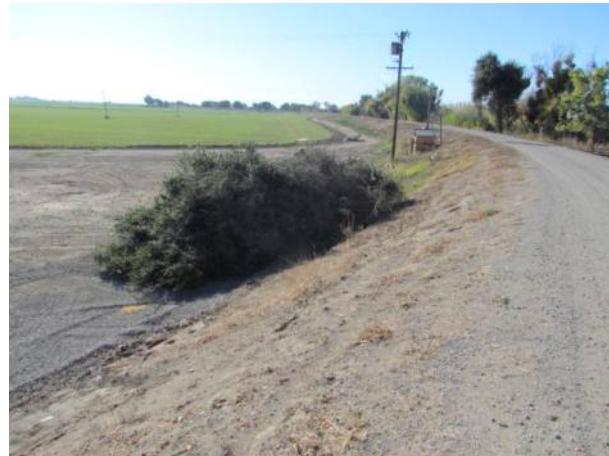
Levee Mile Report Line	42
Start Levee Mile	1.98
End Levee Mile	1.98
Location	Land Side
Category	Earthen Levee
Item	Encroachments
Looking southeast at prunings at landward toe.	
richard_f_20131021_102.JPG

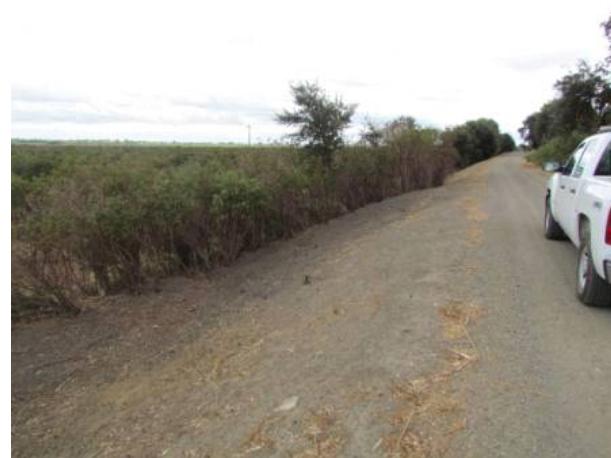
Levee Mile Report Line	48
Start Levee Mile	2.44
End Levee Mile	2.45
Location	Land Side
Category	Earthen Levee
Item	Vegetation
Look southeast at updated (10/11) view of elderberries on landside slope.	
richard_f_20130930_597.jpg

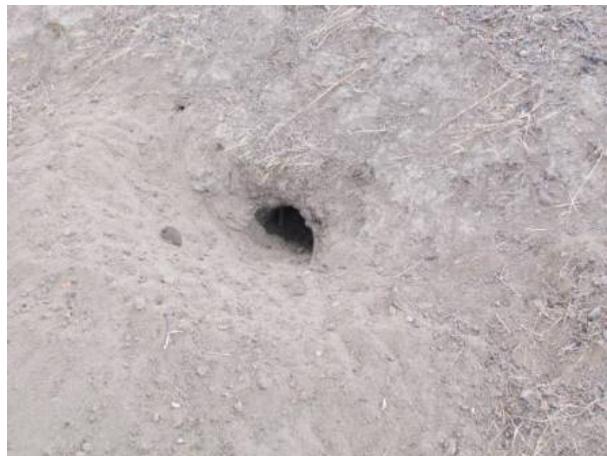
Levee Mile Report Line	51
Start Levee Mile	2.58
End Levee Mile	2.61
Location	Land Side
Category	Earthen Levee
Item	Animal Control
Looking east at rodent hole on landside slope.	
richard_f_20130930_716.jpg

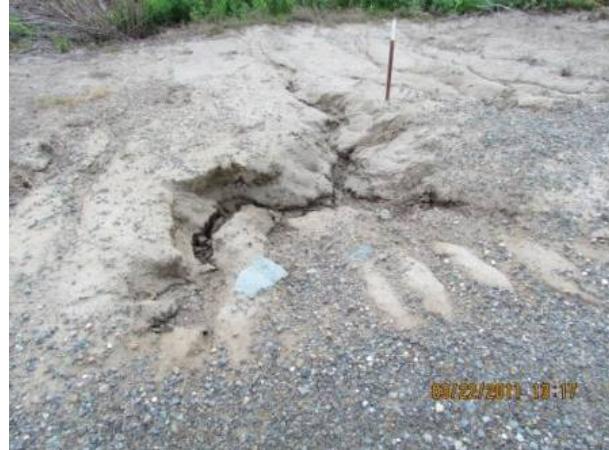
Levee Mile Report Line	59
Start Levee Mile	3.13
End Levee Mile	3.13
Location	Land Side
Category	Earthen Levee
Item	Slope Stability
Looking east at slope erosion cause by runoff on landside slope.	
richard_f_20130930_705.jpg

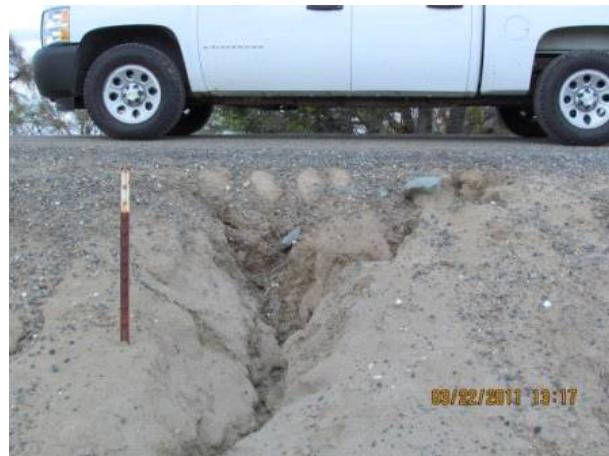
Levee Mile Report Line	59
Start Levee Mile	3.13
End Levee Mile	3.13
Location	Land Side
Category	Earthen Levee
Item	Slope Stability
Looking west at slope erosion cause by runoff on landside slope.	
richard_f_20130930_706.jpg

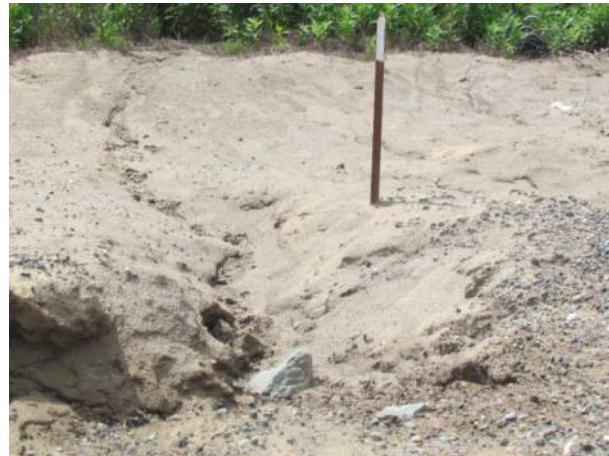
Levee Mile Report Line	59
Start Levee Mile	3.13
End Levee Mile	3.13
Location	Land Side
Category	Earthen Levee
Item	Slope Stability
Looking east at slope erosion. (Updated Spring 2012)	
richard_f_20130930_707.jpg

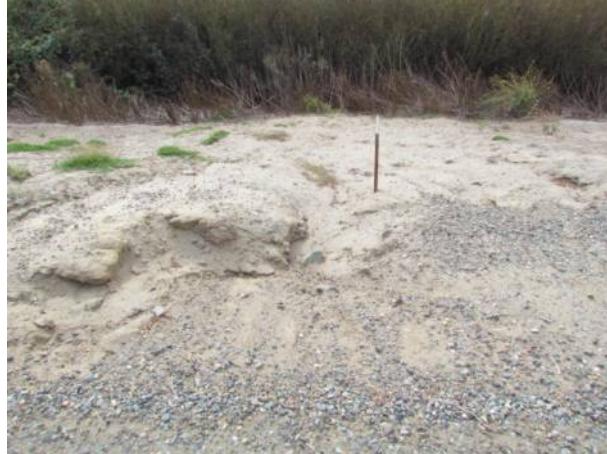
Levee Mile Report Line	59
Start Levee Mile	3.13
End Levee Mile	3.13
Location	Land Side
Category	Earthen Levee
Item	Slope Stability
Looking east at slope damage on 10/31/2012, no change in status.	
richard_f_20130930_708.JPG

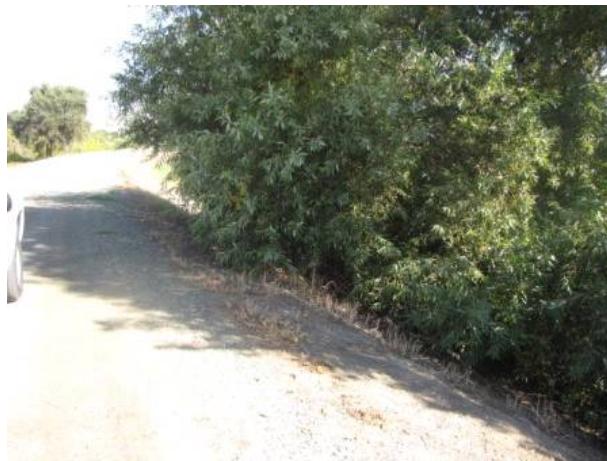
Levee Mile Report Line	60
Start Levee Mile	3.28
End Levee Mile	3.28
Location	Land Side
Category	Earthen Levee
Item	Trim / Thin Trees
Looking southeast at dense trees on landside slope and toe.	
richard_f_20130930_693.jpg

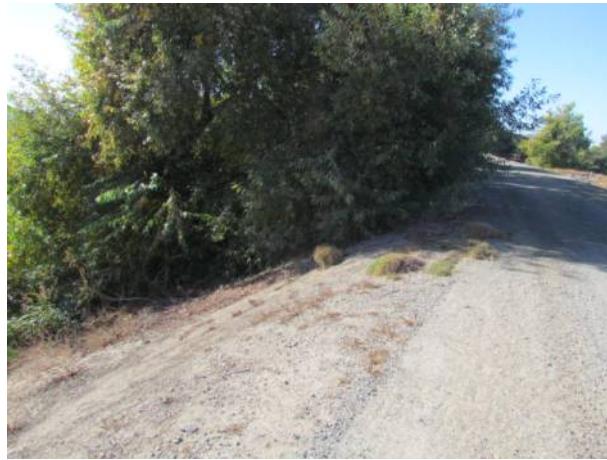
Levee Mile Report Line	60
Start Levee Mile	3.28
End Levee Mile	3.28
Location	Land Side
Category	Earthen Levee
Item	Trim / Thin Trees
Looking south at dense trees on landward slope.	
richard_f_20131021_105.JPG

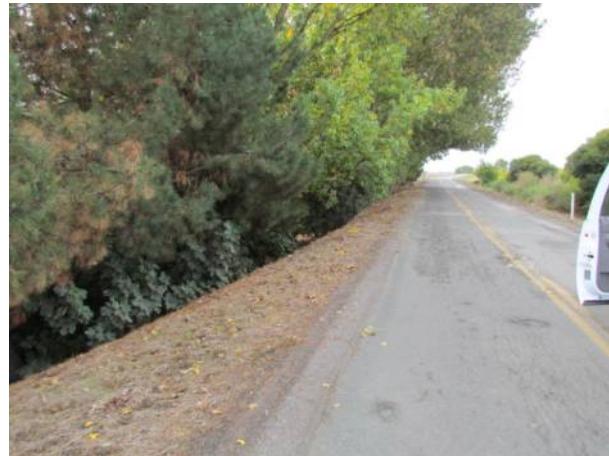
Levee Mile Report Line	66
Start Levee Mile	4.73
End Levee Mile	4.80
Location	Land Side
Category	Earthen Levee
Item	Trim / Thin Trees
Looking south at dense trees on landside slope and toe.	
richard_f_20130930_717.JPG

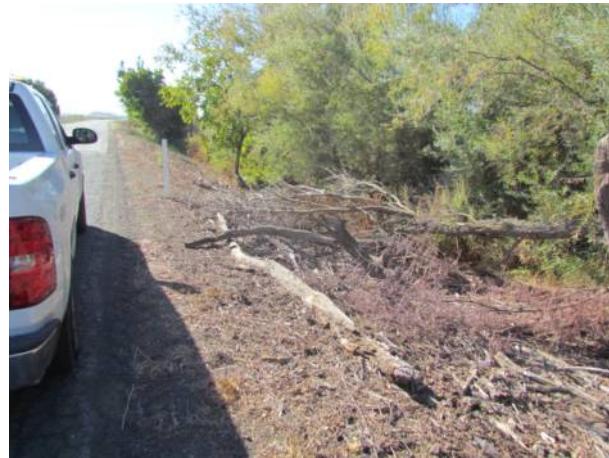
Levee Mile Report Line	81
Start Levee Mile	6.97
End Levee Mile	6.97
Location	Water Side
Category	Earthen Levee
Item	Encroachments
Looking south at tree limbs on waterward slope.	
richard_f_20131021_106.JPG

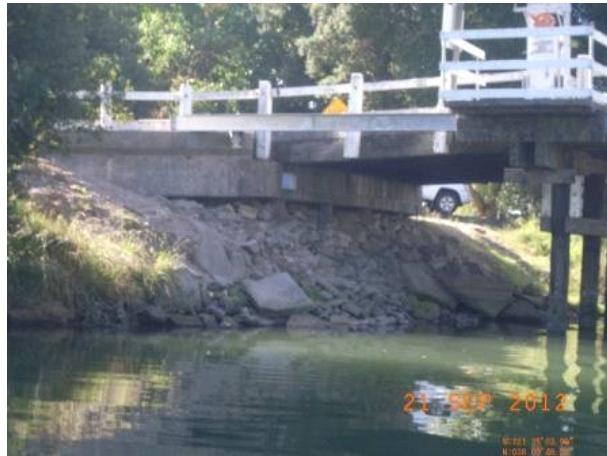
Levee Mile Report Line	84
Start Levee Mile	7.56
End Levee Mile	7.82
Location	Water Side
Category	Supplemental
Item	USACE Erosion Survey
USACE 2012 Photo #2	
USACE2013_GEO_4-5_L_2.jpg

84	7.56	7.82	Supplemental USACE Erosion Survey	WS	U Ma	Inspector Comments: 1997 - Pocket erosion at upstream end and into the levee toe under the Alder trees. 2003 - New brush boxes with wattles on bank. 2004 - No brush boxes. 2005 - Site extended from the downstream side of the bridge. Whole bank is vertical. 2010 - Some minor new erosion. 2011 - Site upgraded to CRITICAL. New erosion pockets throughout the site. Sites 4.5, and 4.6 were combined. 2012: No observed change. [2012 Site ID: GEO_4-5_L]	38.164462 ° -121.583092 °	38.160888 ° -121.584807 °	45 Y	DWR ID:
85	7.66	7.66	Earthen Levee	Encroachments	WS M Ma	TR : Tree or limb Inspector Comments: Broken tree branch on waterside slope.	38.164927 ° -121.582680 °	38.164927 ° -121.582680 °	89 Y	DWR ID: DWR_RD0563_01_s_2012_89
86	7.79	7.79	Earthen Levee	Slope Stability	LS M Ma	S1 : Repair slope instability. Inspector Comments: Minor erosion on landside shoulder and slope.	38.163240 ° -121.583328 °	38.163240 ° -121.583328 °	97 Y	DWR ID: DWR_RD0563_01_s_2013_97

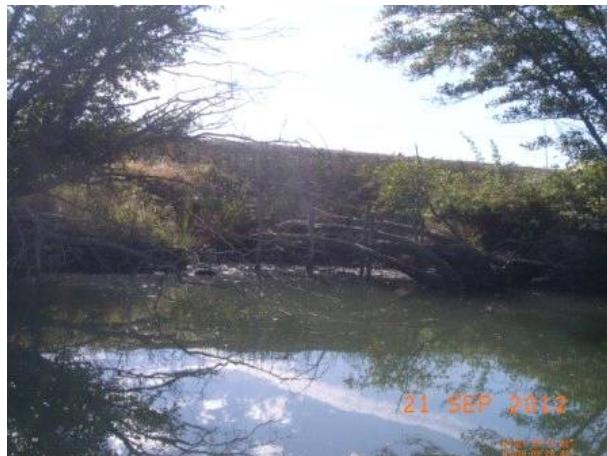
Levee Mile Report Line	87
Start Levee Mile	7.87
End Levee Mile	8.07
Location	Water Side
Category	Supplemental
Item	USACE Erosion Survey
USACE 2012 Photo #1	
USACE2013_GEO_4-3_L_1.jpg

87	7.87	8.07	Supplemental USACE Erosion Survey	WS M Ma		Inspector Comments: 1997 - Pockets of erosion into the levee toe. 1999 - Minor rock riprap and willow bundles place in a couple of spots. 2001 - Staked, low fascine walls at bankline. 2003 - Small unprotected pockets still eroding. 2004 - Numerous brush boxes, some falling apart, some with new bundles. 2005 - Some new brush boxes installed; some boxes are empty. Levee slope and banks still look bad with pocket scallops into the levee slopes. 2011 - Erosion continues and the number of pockets is increasing. 2012: No observed change. [2012 Site ID: GEO_4-3_L]	38.160261 ° -121.585056 °	38.157625 ° -121.586543 °	46 Y	DWR ID:
88	7.91	7.95	Earthen Levee	Trim / Thin Trees	LS M Ma	T1 : Trim trees to at least five feet above ground level.	38.161607 ° -121.584258 °	38.161092 ° -121.584470 °	29 Y	DWR ID: DWR_RD0563_01_s_2012_29
89	7.97	8.10	Earthen Levee	Vegetation	LS M Ma	V2 : Remove the wild growth other than native grasses from the levee slopes. Inspector Comments: Berryvines and willows on landside toe.	38.160800 ° -121.584598 °	38.160487 ° -121.584717 °	90 Y	DWR ID: DWR_RD0563_01_s_2012_90

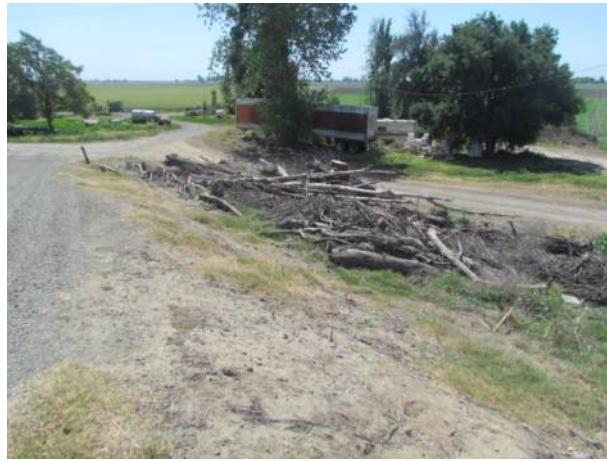
Levee Mile Report Line	95
Start Levee Mile	9.50
End Levee Mile	9.50
Location	Land Side
Category	Earthen Levee
Item	Encroachments
Looking east at prunings on landward slope. (Spring 2013)	
richard_f_20130930_698.JPG

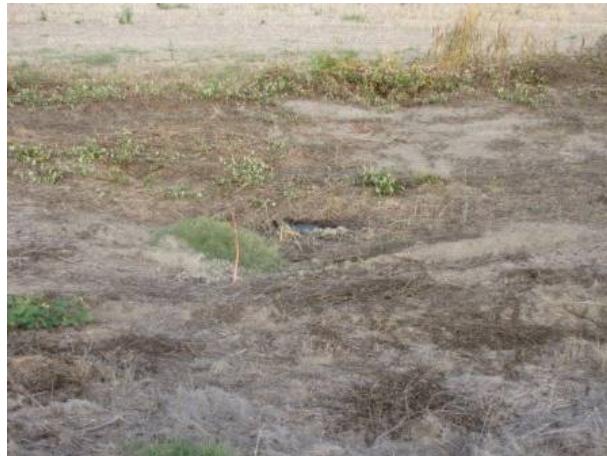
Levee Mile Report Line	102
Start Levee Mile	10.77
End Levee Mile	10.77
Location	Land Side
Category	Earthen Levee
Item	Slope Stability
Looking east at water ponding at landside toe just above 10" irrigation pipe.	
richard_f_20130930_704.jpg
